EVALUATION OF THE SPRAY ICE BARRIER AT THE CIDS ANTARES SITE DURING 1985 USING TIMELAPSE PHOTOGRAPHY

FINAL REPORT February 1988

POLAR ALPINE, INC.

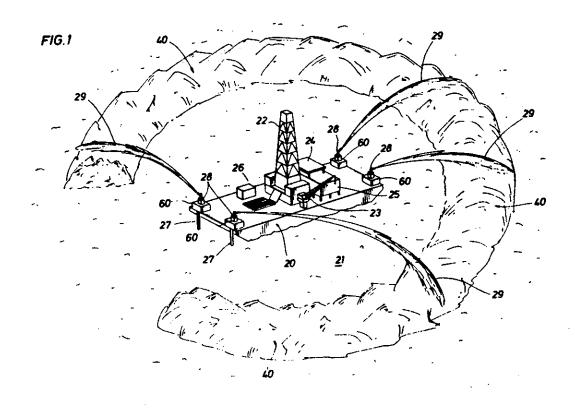
The spray ice barrier formed around the Beaufort Sea I in late 1984 had a horseshoe shape with the open end of the horseshoe facing south. Figure 1, which is reproduced from the Finucane and Jahns patent shows an artist's rendition of a spray ice barrier being constructed around a drilling barge. The representation of the spray ice barrier, the drilling barge and the construction detail are similar to the spray ice barrier actually constructed around the Beaufort Sea I, including the opening left at the south end of the structure.

Figure 1. A drawing of a spray ice barrier being constructed around an offshore drilling structure. This figure is taken from U.S. Patent 4,523,879.

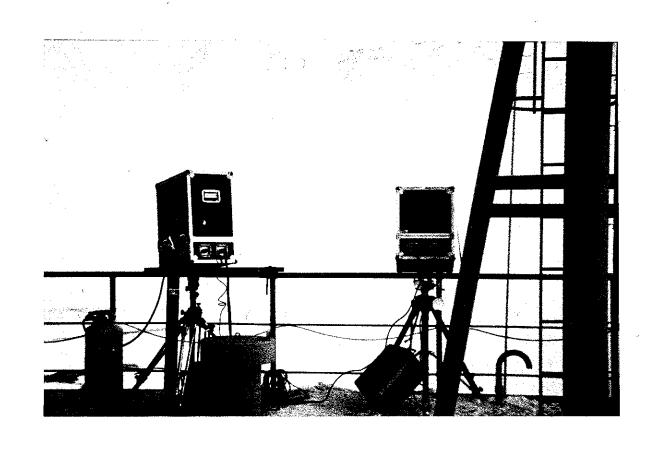
Photograph 1 shows two camera enclosures located on the CIDS. This installation is typical of the camera installations deployed on the CIDS.

Photograph 1. An example of the camera placement on CIDS showing the camera enclosures and associated hardware.

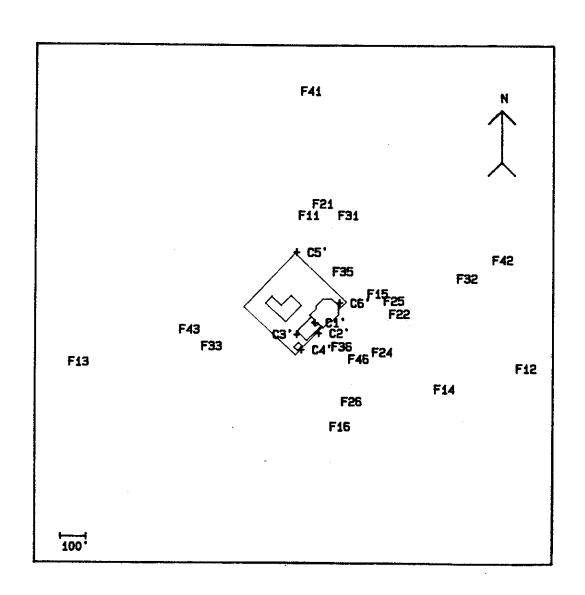
When the cameras were removed from the barrier they were relocated at various locations on the CIDS. Figure 3 is a schematic representation of where the cameras were located.

The cameras are designated as Cl through C6 on Figure 3. The points designated as F## are the location of surveying flags that were located on the ice barrier and on the natural sea ice.

Figure 3. Camera locations on the CIDS and the initial location of the survey flags placed on the ice to verify pixel coordinates. C# indicates camera locations and F# indicates flag locations.

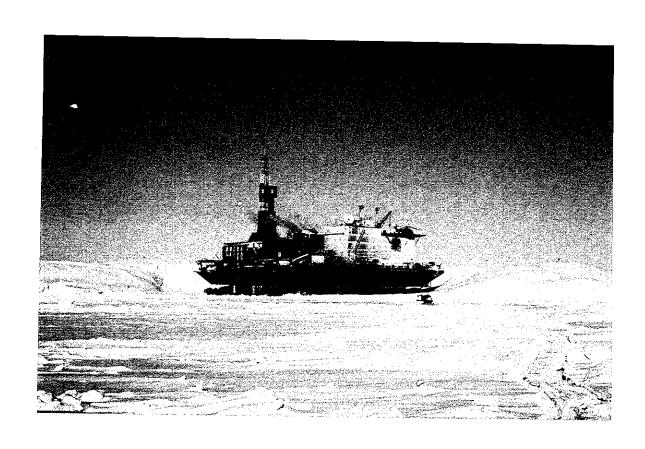
Photograph 4, taken looking north into the open end of the spray ice barrier, provides a view of the CIDS and the spray ice barrier taken from level ice to the south. This photograph is similar to the above-ice portion of the cross-section of the barrier shown in Figure 2. To provide scale for this photograph, the main deck of the CIDS is approximately 50 feet above the level sea ice and the height of the top of the living quarters structure is 106 feet above the level sea ice. The width of the structure viewed in this photograph is 400 feet (across diagonal corners).

Photograph 4. View from sea level of CIDS and the spray ice barrier. This photograph was taken looking north. Note the helideck is approximately 100 feet above sea level.

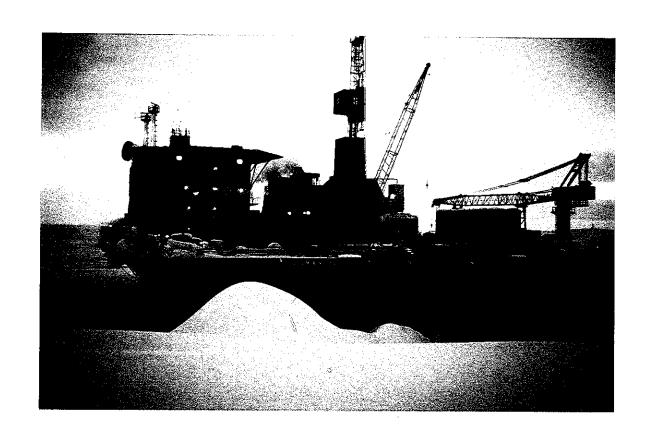
Typical heights at the crest of the barrier were from 50 to 75 feet above sea level (Jahns & Petrie, 1986). Photograph 5 is taken from the top of the spray ice barrier looking toward the CID3. As the photograph demonstrates, the height at which the photo was taken is nearly level with the main deck, which is at a height of approximately 50 feet above sea level.

Photograph 5. Photograph of CIDS from the spray ice barrier looking toward the southwest. Note the height of the barrier relative to the elevation of the deck which is approximately 50 feet above sea level.
